# Garmin Nuvi 2589LMT Speaker Replacement

A simple guide to replace your Garmin Nuvi 2589LMT speaker.

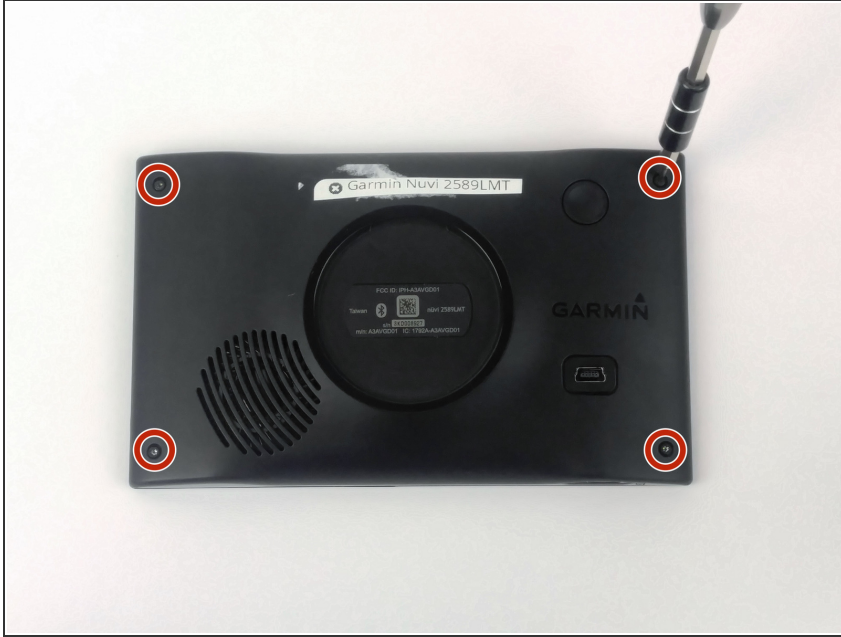
## Step 1 — Back Panel Assembly

- Using the T5 Torx Screwdriver, remove all 4 of the 5.7mm screws from the back of the device.

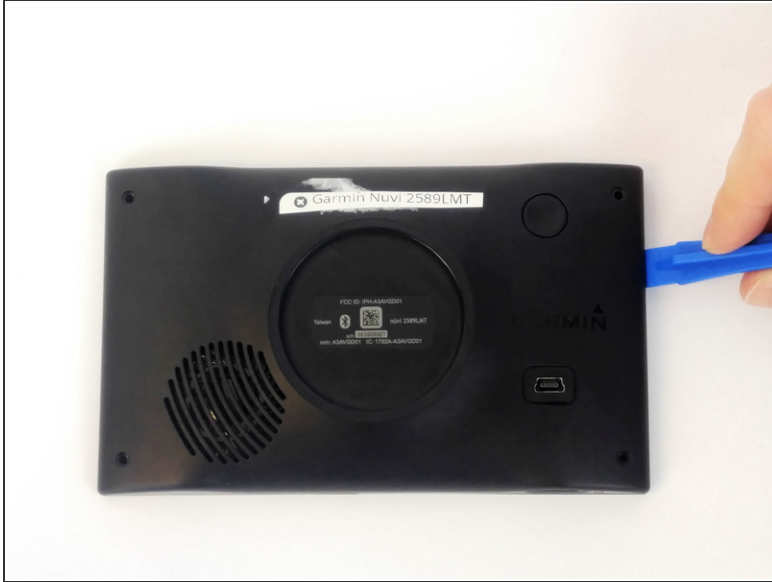
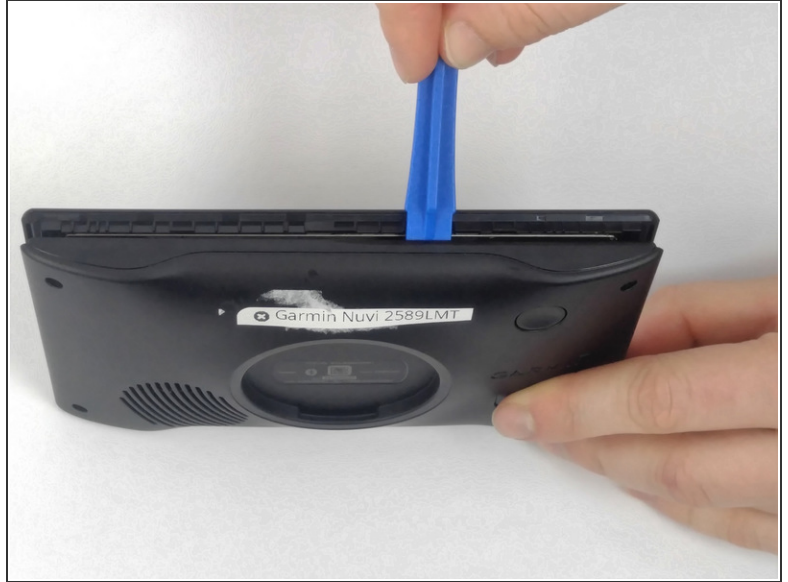
## Step 2

- Using the plastic opening tools, pry the shorter sides of the device apart.
  - Once a gap has formed at the top of the device, insert the opening tool into the gap and slide it along the top of the device. Repeat for the bottom edge of the device to separate the LCD screen from the back.
- ⚠ Do not disconnect or tear the ribbon wiring, located at the bottom of the motherboard, when removing the back of the device.

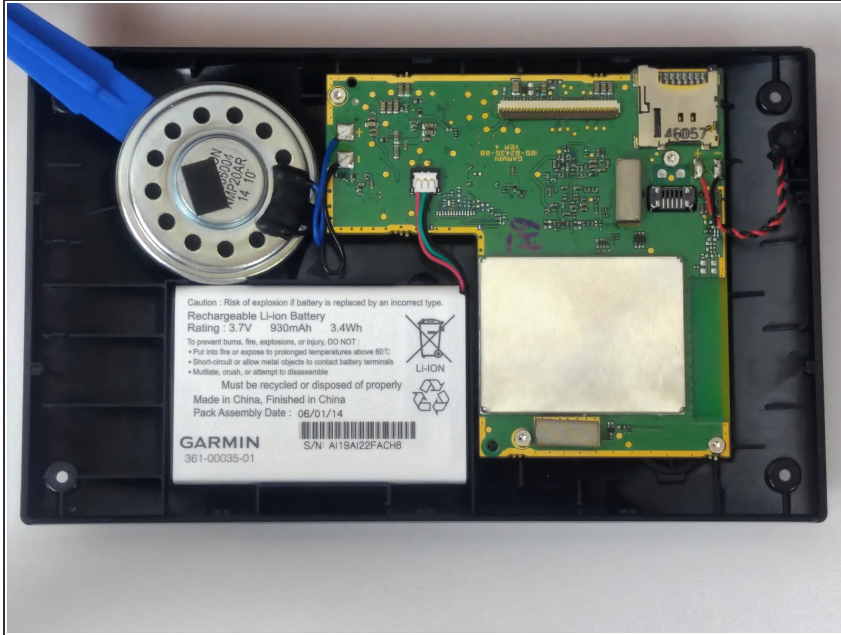
## Step 3 — Speaker

- Wedge the speaker from the device, using the small plastic opening tool.
- ⓘ The speaker is held in place by adhesive tape on the outer rim. Because the speaker is still connected to the motherboard, pry the speaker away from the device gently.

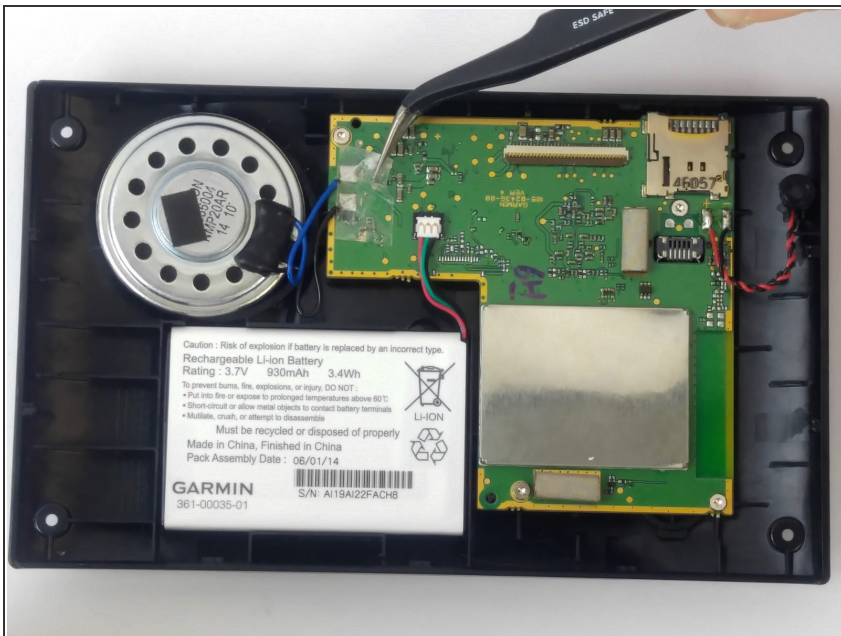
## Step 4

- Using tweezers, remove the tape covering the speaker connection to the motherboard.

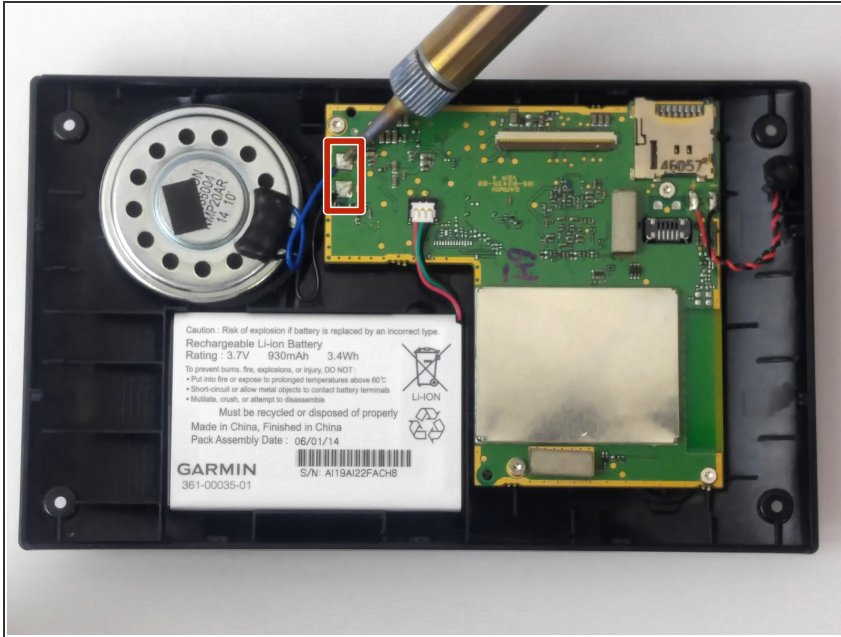
## Step 5

- Using a soldering iron, desolder the wire connection at the soldering points between the speaker and the motherboard to remove.
- ❗ Learn more about soldering and desoldering connections [here](#).
